# ANNUAL PROGRESS REPORT

ARCHÆOLOGICAL SURVEY DEPARTMENT,  
SOUTHERN CIRCLE,

1908-1909.

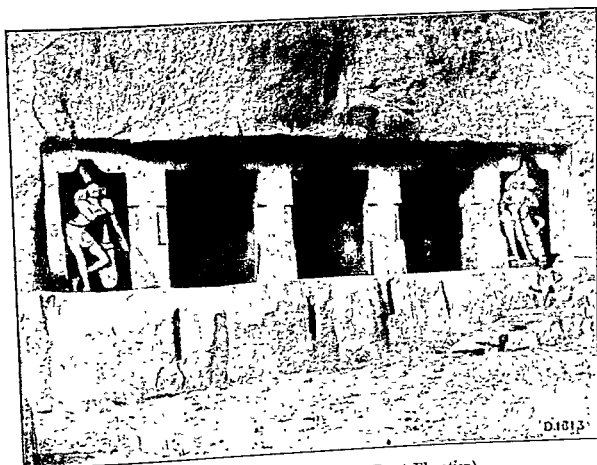
Fig. 6 (a) Mandagapattu temple (Front Elevation).
